**THE CONFEDERATED TRIBES OF THE WARM SPRINGS
RESERVATION OF OREGON JOHN DAY BASIN OFFICE
FY 1999 WATERSHED RESTORATION PROJECTS**

Annual Report 1999

Project Number: 98-018-00

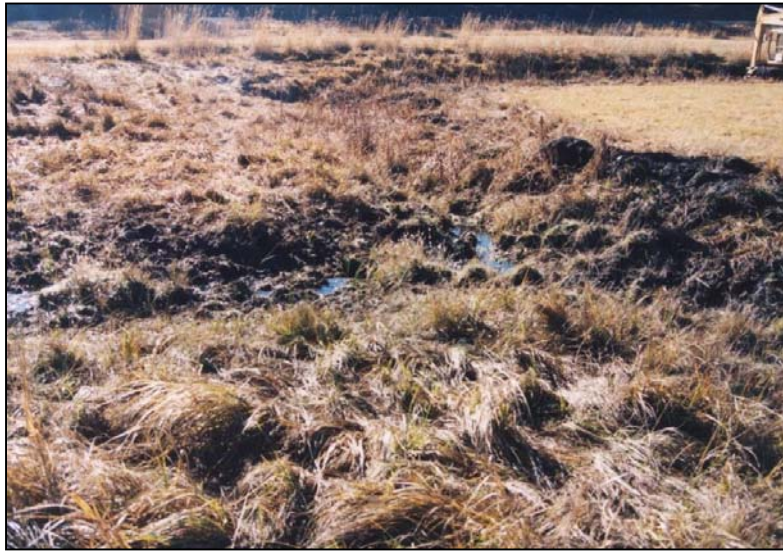
Photo 1. Crown Ranch Irrigation Return Ditch (pre-project)

Water from the John Day River is used to irrigate hay meadows north of the river on the Crown and McNeil ranches. Used irrigation water historically was collected from the fields and returned to the river in open ditches. The quality of return flow water was seriously degraded as it was exposed to direct sunlight, bare soil, and nutrients (animal waste) from the fields. When this water was returned to the river, it typically contributes to water quality degradation in the river.

The project replaced the open ditches with perforated PVC pipe. The pipes collect return flows below ground and transport this water to the river directly, thereby eliminating thermal and nutrient increases. In addition, installation of a valve station allows for regulation of the local water table to enhance forage production and the extent of return flows. Our experience and monitoring of prior similar projects, shows a remarkable increase in water quality of return flows and improvements in localized water quality in the river water column.

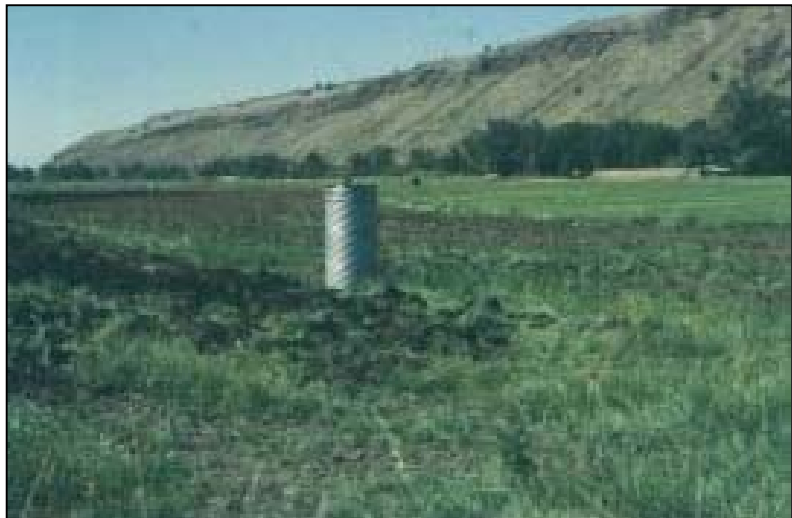
Photo 2. Crown Ranch irrigation return flow system showing water control station (post-project)

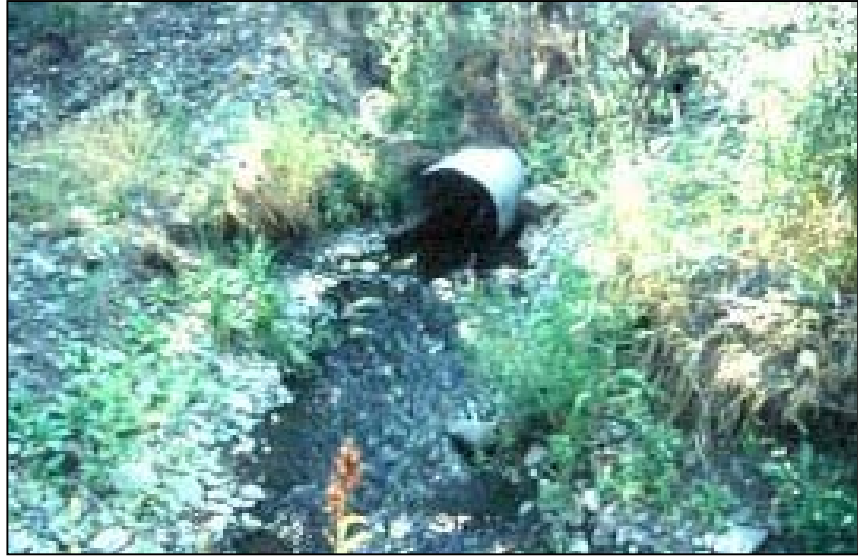
Photo 3. Crown Ranch return flow outlet (post-project)

1. Install perforated pipe over the project area to replace open ditches.
2. Install a valve station at the drain confluence with the river to allow adjustment of the local water table as necessary.
3. Install a safety screen over the outlet pipe to preclude entrainment of wildlife.
4. Place riprap around the outlet pipe to prevent streambank and bed erosion.
5. Shape all construction spoils as appropriate to reduce erosion and to promote rapid vegetative recovery.
6. Rebuild the existing riparian corridor fence around the construction area, as necessary.

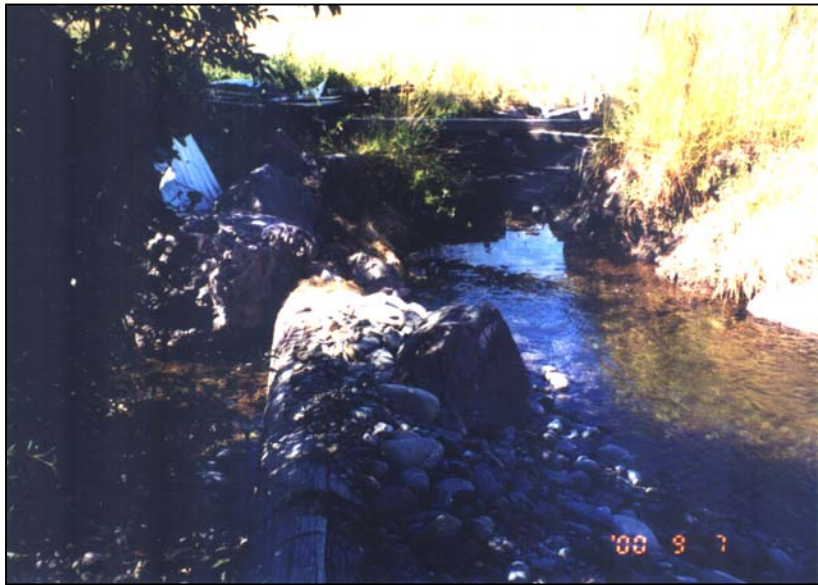
**Photo 4. Indian Creek diversion (pre-project)**

Project Background: Indian Creek water was historically diverted into two open ditches by constructing gravel dikes across the creek. The temporary gravel berms were reconstructed annually (near the beginning of the irrigation season), and as required during the irrigation season as river flows declined. In addition to the effects of construction on the stream channel and riparian area, depending upon river flow conditions the diversions created partial to total barriers to migrating fish. These migratory barriers can become a problem at various times during the year as follows:

- 1) if stream flows are low in the spring and the push-up diversion is not “blown out”¹ or removed, a passage impediment can be created for adults migrating upstream to spawning areas;
- 2) when water temperatures in the mainstem and lower reaches of the tributaries cool in the fall, large numbers of rearing juveniles and stream resident adults outmigrate to overwintering areas. If diversions remain in place, they can become an impediment for outmigrants to move to more productive overwintering habitat areas;
- 3) if diversions are not blown out or removed in the spring prior to smolt outmigration they may become an impediment to smolt migration or entrain smolts; and
- 4) as summer water temperatures create uncondusive conditions in the mainstem and lower reaches of rearing tributaries, juveniles and stream resident adults must migrate to areas of

1. Install a permanent concrete and rock diversion structure at the existing ditch head, which is the legal point of diversion.
2. Construct a concrete turnout box and spillway, incorporating a trash screen to protect the turnout box, a headgate for water regulation, and a water measuring weir as appropriate.

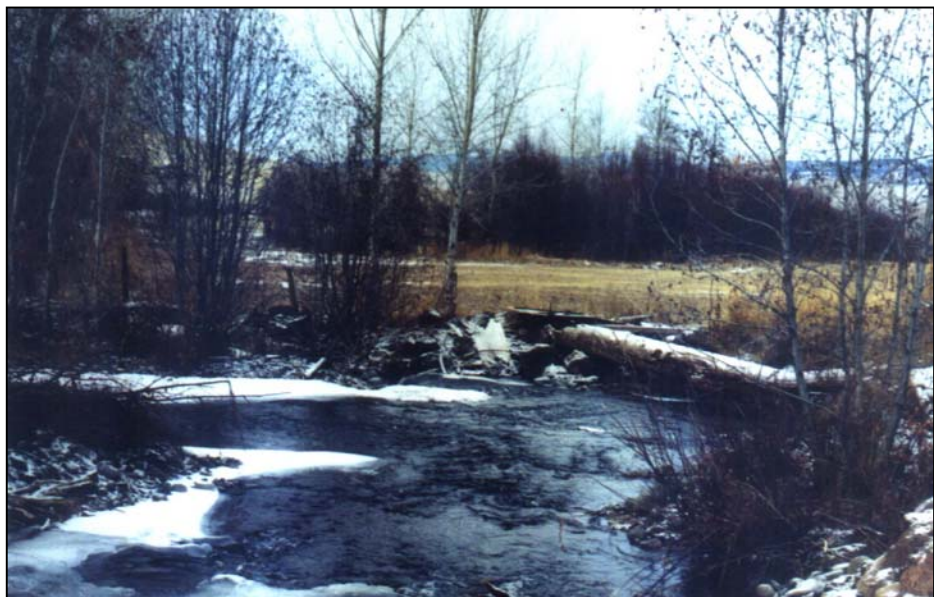
Photo 5. Indian Creek diversion (post-project)

3. Install layflat stanchions in the spillway to allow for placement of flashboards that regulate the impounded water level during the irrigation season.

4. Place riprap in conjunction with sheet steel piling in the bed of the river on grade relative to the point of diversion to ensure flow over the fishway under all normally occurring river levels.

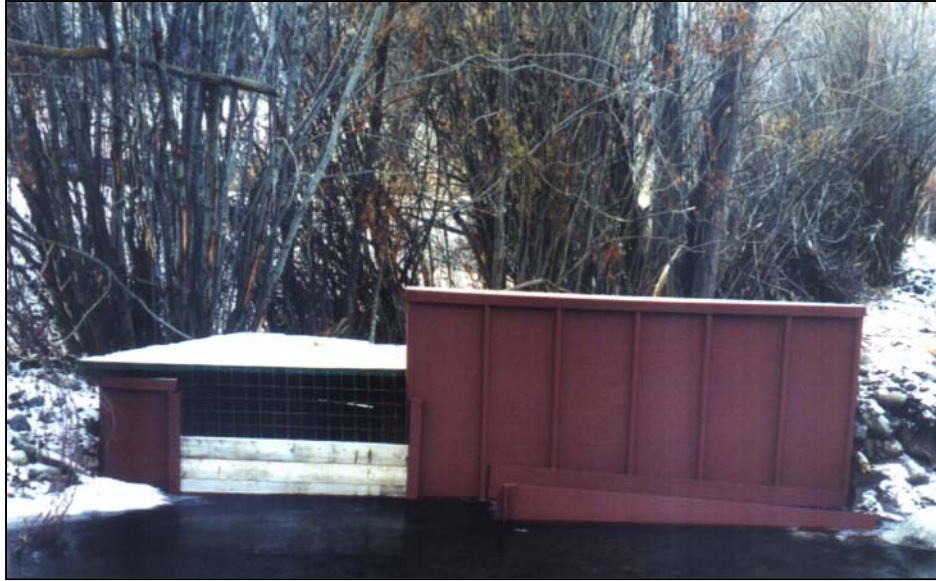
Photo 6. Indian Creek diversion turnout box

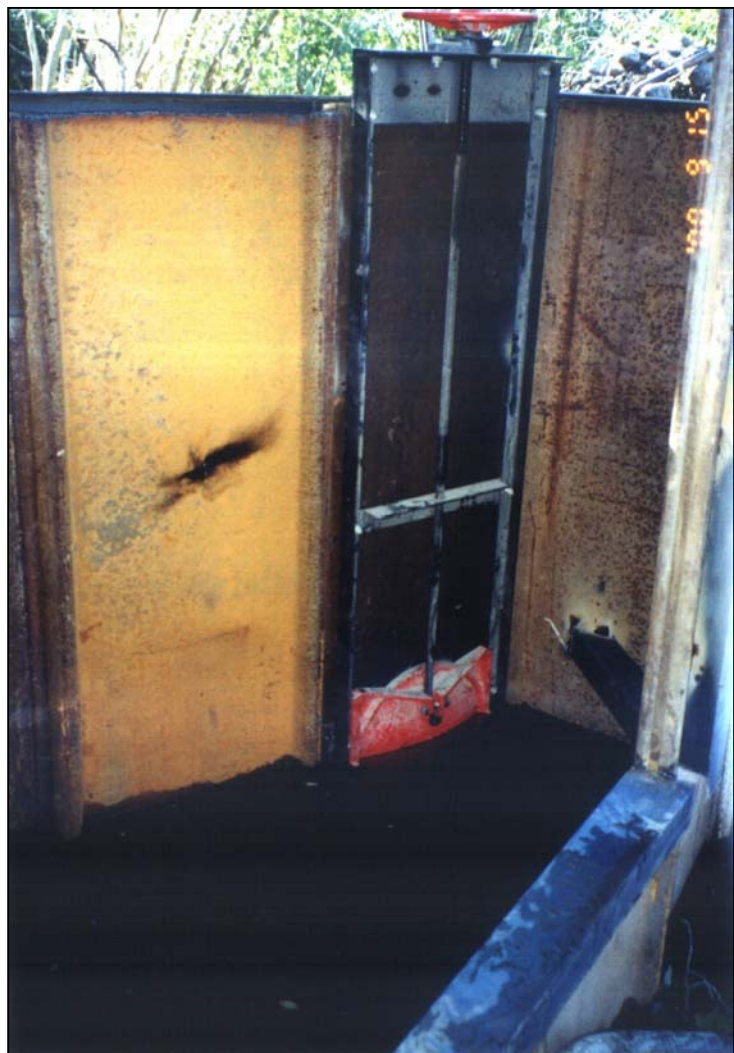
Photo 7. Indian Creek diversion turnout box with headgate

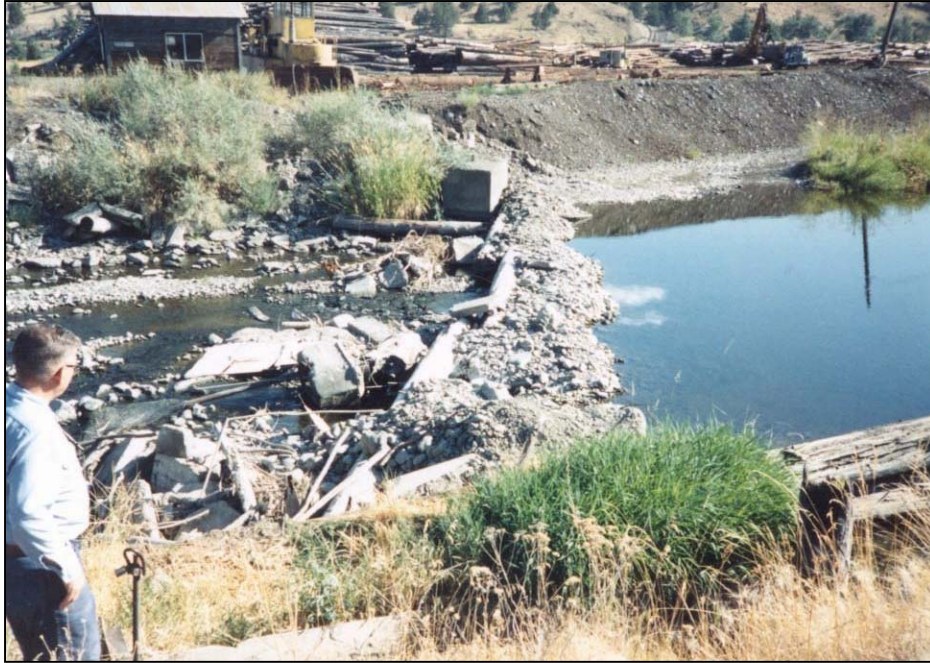
Photo 8. Typical gravel push-up diversion in the John Day basin

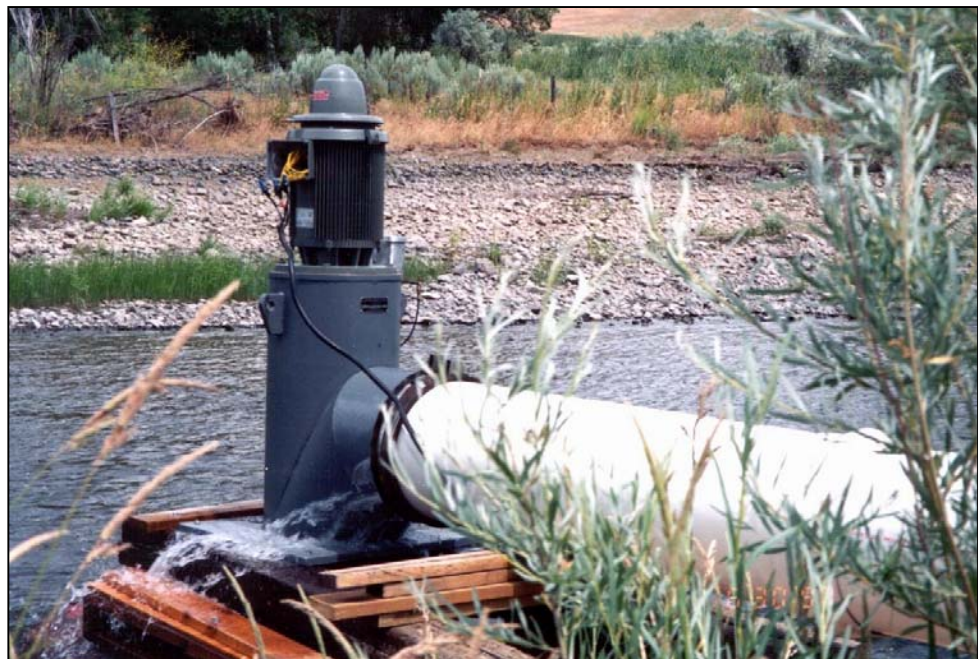
diversions. They differ from permanent diversions and infiltration galleries in that the collection system consists of a pump, on a pump pad, with a suction nozzle extending into the water column. Generally, the pump is placed in a natural pool in the river, although sometimes a small diversion structure is needed to pool water to a sufficient height to be pumped to a conveyance system.

Photo 9. Typical pump station in the John Day basin

1. Install one 7.5 HP low pressure pump to provide irrigation water to approximately 62 acres.

2. Install NMFS approved fish screen on pump suction.
3. Install approximately 240 feet of 8-inch PVC from pump to existing open delivery system.
4. Shape and stabilize the disturbed streambank. Repair existing riprap by adding 5-cubic yards of riprap grade rock.
5. Seed disturbed areas.

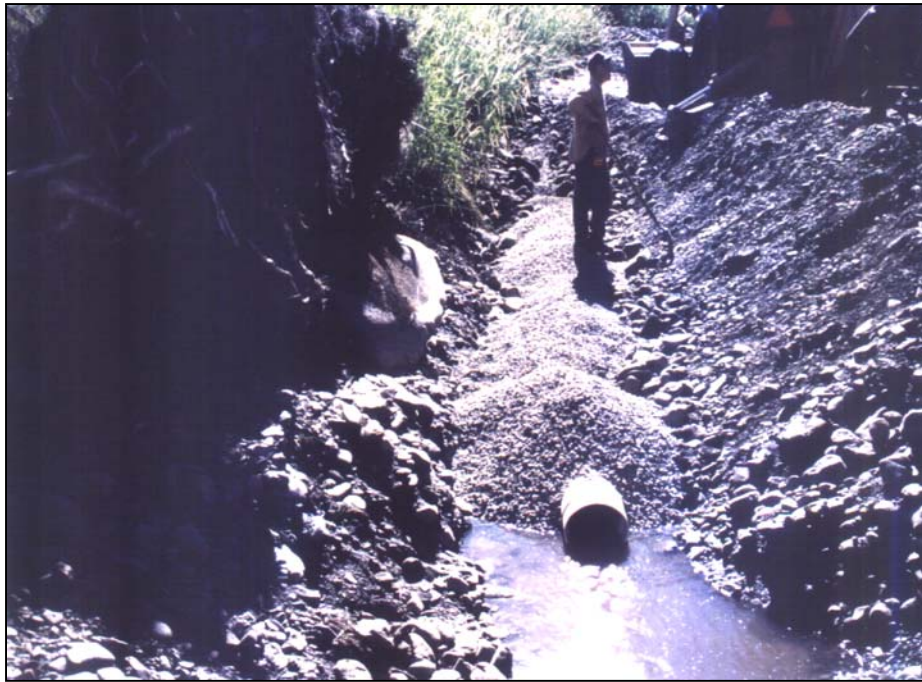
Photo 10. Infiltration gallery well screens being placed in an excavated trench below the streambed

Infiltration galleries are promoted in the John Day basin as a replacement option for gravel push-up diversions. They differ from permanent diversions and pumping stations in that the collection system consists of well screens buried below the surface of the streambed. Water collected in the well screens is then gravity fed or pumped to a distribution and conveyance system. No

1. Excavate for and install the buried well screens underneath the creek.
2. Install a shutoff valve and riser to allow backflushing the system.
3. Install PVC conveyance pipe.
4. Place riprap on the streambank to assure erosion will not damage the gallery or bypass the collection system.
5. Stabilize the west bank of the stream as necessary with riprap to protect the installation and shape spoils on both banks.
6. Shape all construction spoils as appropriate to reduce erosion and to

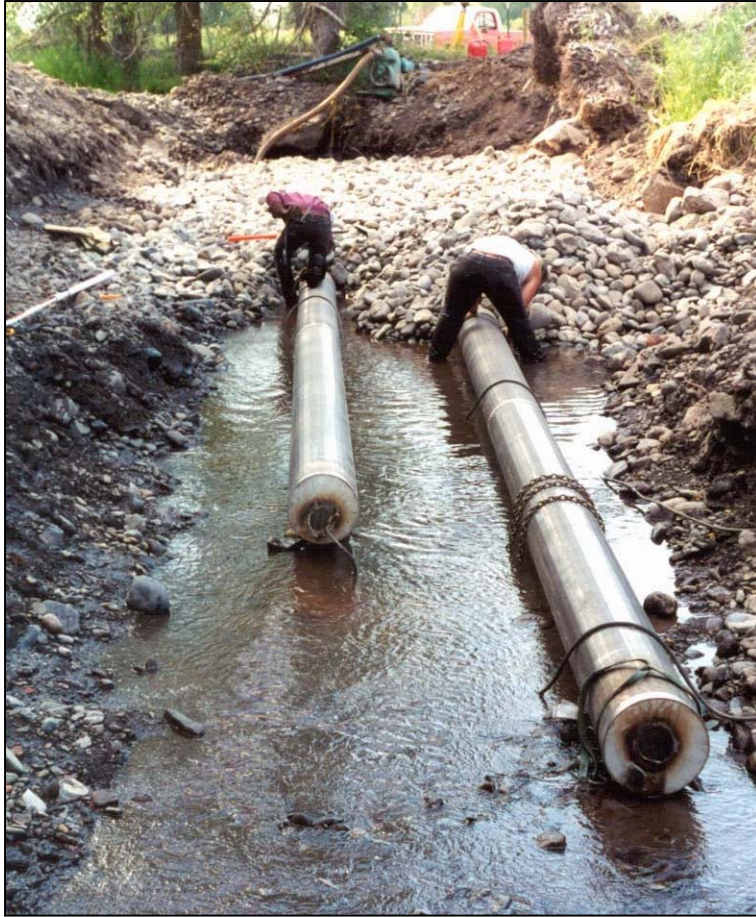
Photo 11. Well screens being installed beneath streambed

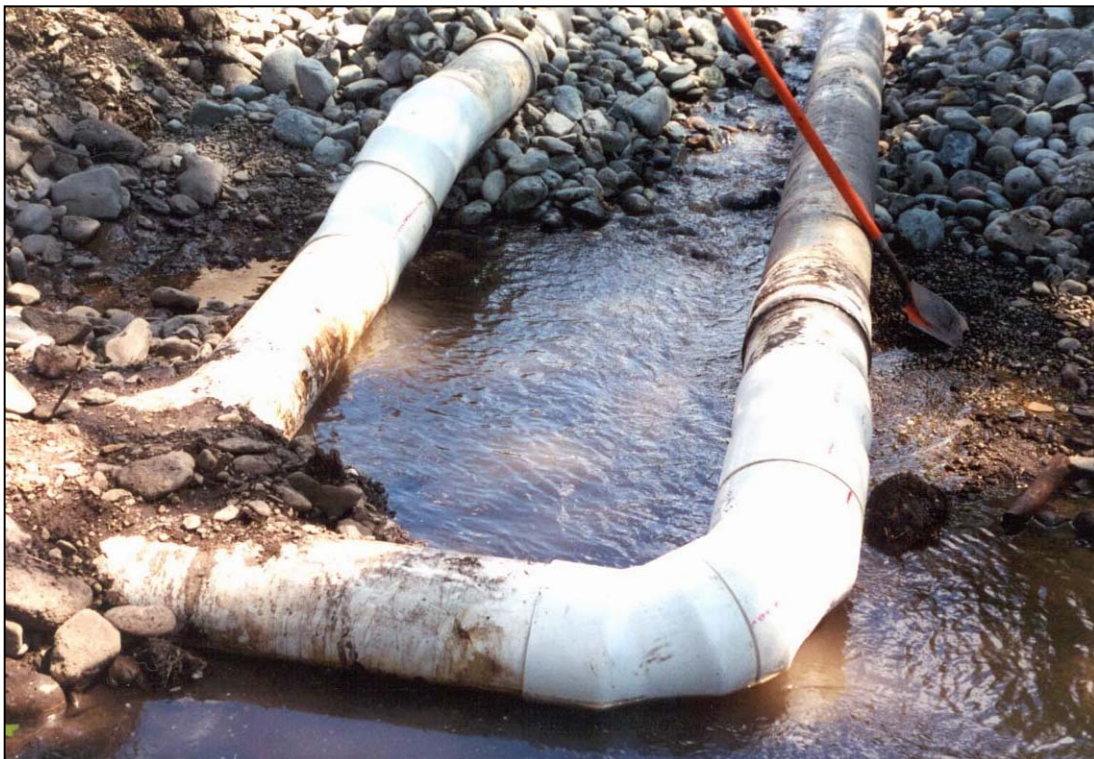
Photo 12. Manifold attached to well screens

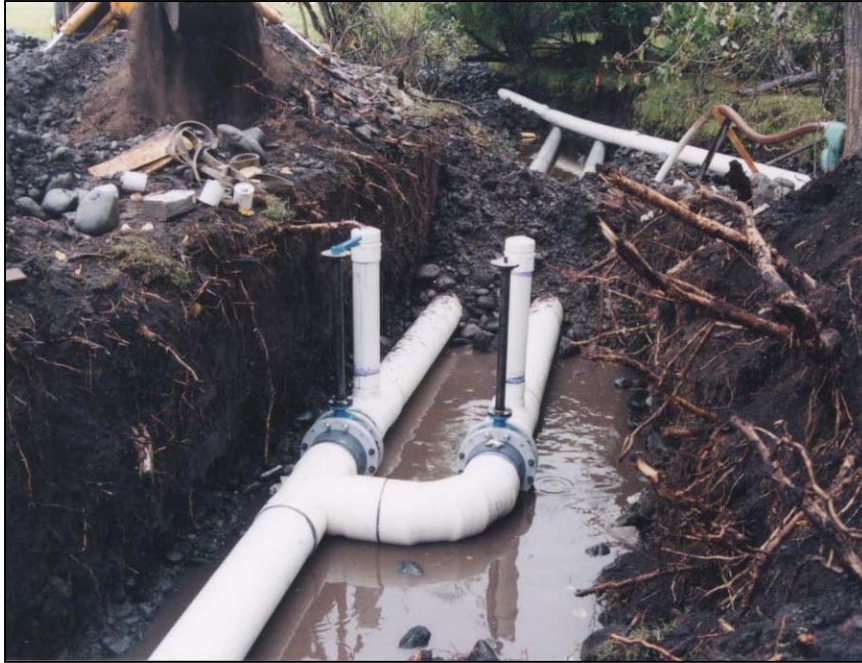
Photo 13. Upright risers attached to well screen manifold

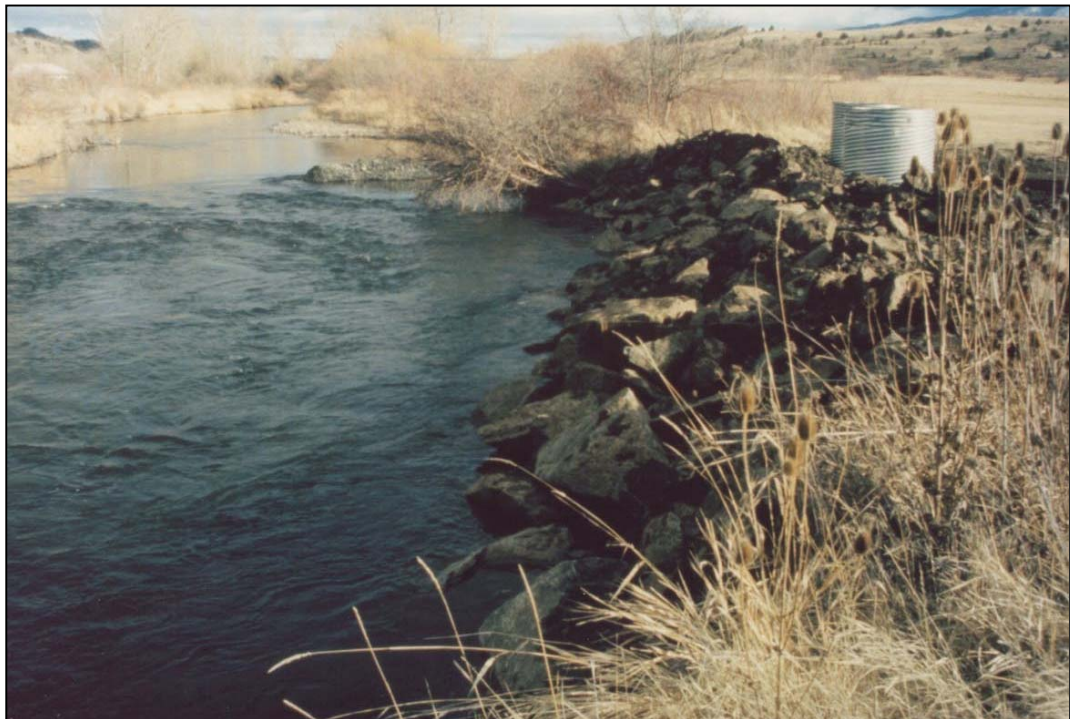
Photo 14. Typical infiltration gallery following installation. The well screens are not visible below the streambed. The upright CMP pipe houses the water control and backflushing valves.

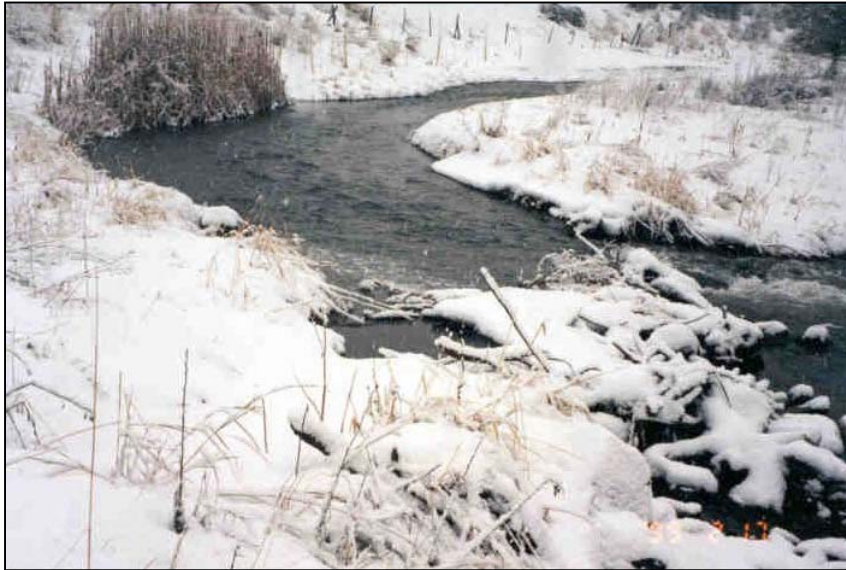
**Photo 15. Keerins diversion prior to project construction.**

Project Background: See description of the Indian Creek diversion for background information on gravel push-up dams and their effects. The Keerins Diversion is located on the South Fork John Day River within spawning and rearing habitat for resident fish and above spawning and rearing habitat for summer steelhead and spring Chinook salmon.

1. Install a permanent concrete, steel, and rock diversion structure at the existing ditch head, which is the legal point of diversion.
2. Construct a headgate for water regulation and install a water measuring weir.
3. Install layflat stanchions in the spillway to allow for placement of flashboards that regulate the impounded water level during the irrigation season.

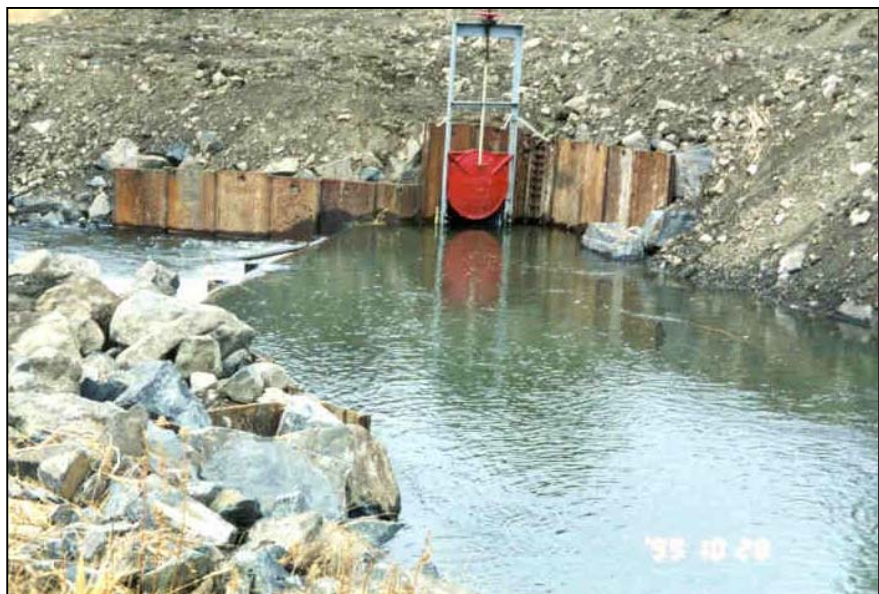
Photo 16. Keerins diversion following project installation. Flashboards have been installed for illustration purposes, although under most stream flow conditions they are unnecessary since the bottom of the headgate and the bottom of the diversion structure are on level with the bottom of the stream.

4. Place riprap in conjunction with sheet steel piling in the bed of the river on grade relative to the point of diversion to ensure flow over the fishway under all normally occurring river levels.
5. Stabilize the east and west banks of the stream as necessary with riprap to protect the installation and shape the construction spoils on both banks.

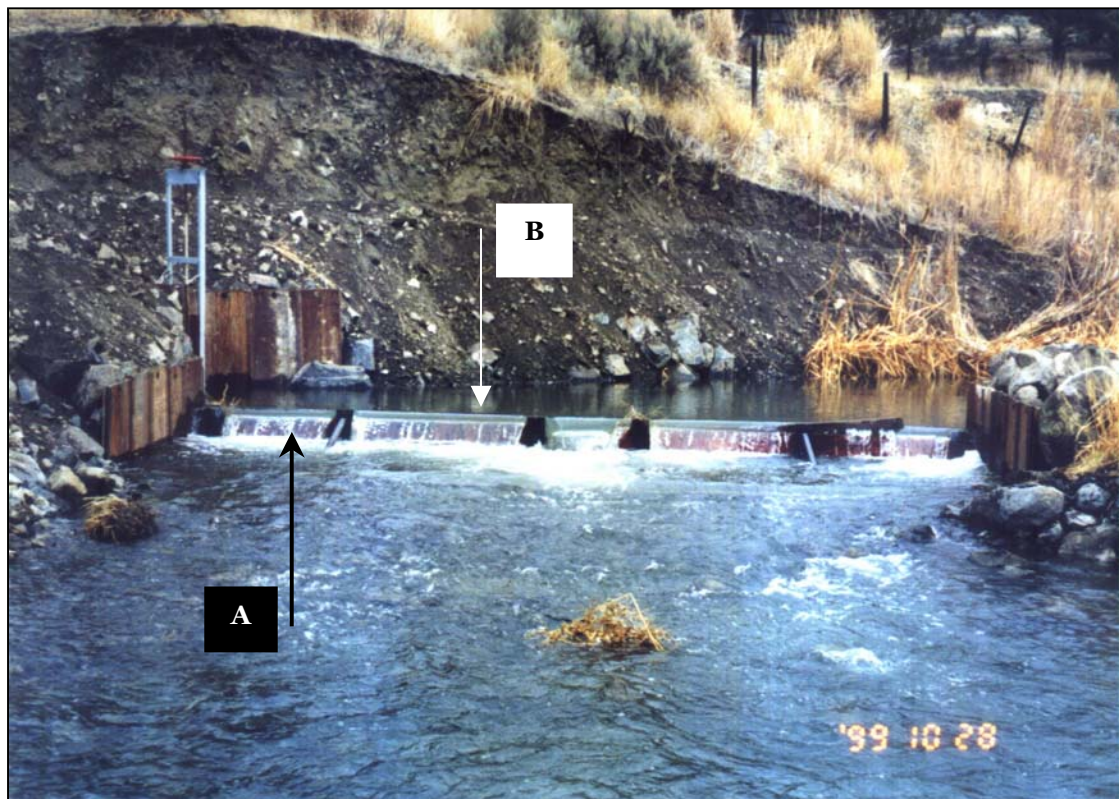
Photo 17. Keerins diversion showing installation of layflat stanchions and flashboards. Middle of stream is fishway notch.

Photo Note:
As boards are placed horizontally upstream of the lay-flat stanchions (A), the water level behind the diversion structure, as well as through the fishway (B), is raised. Fish passage and diversion of irrigation water to legal rate and duty is assured at all flow levels.

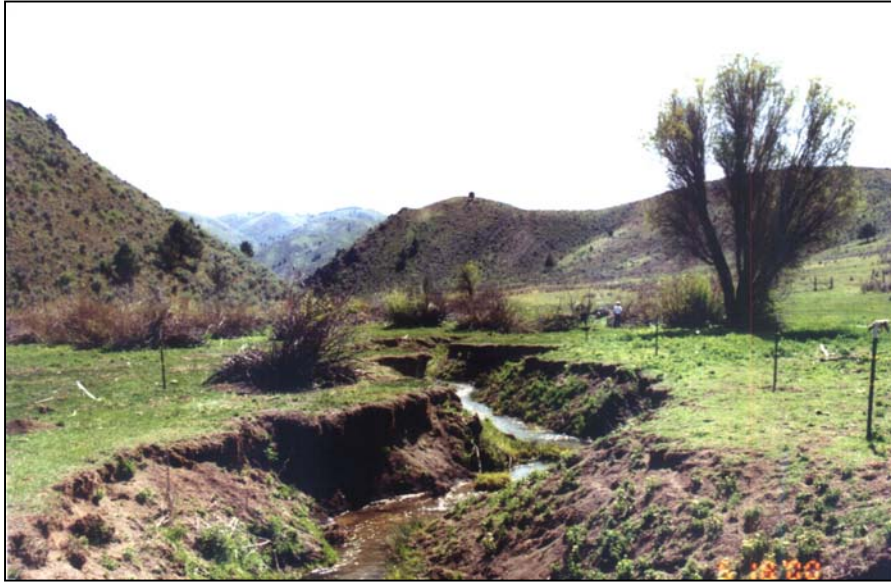
Photo 19. Rosebud Creek, a tributary of the South Fork John Day River, showing installation of the temporary electric fence

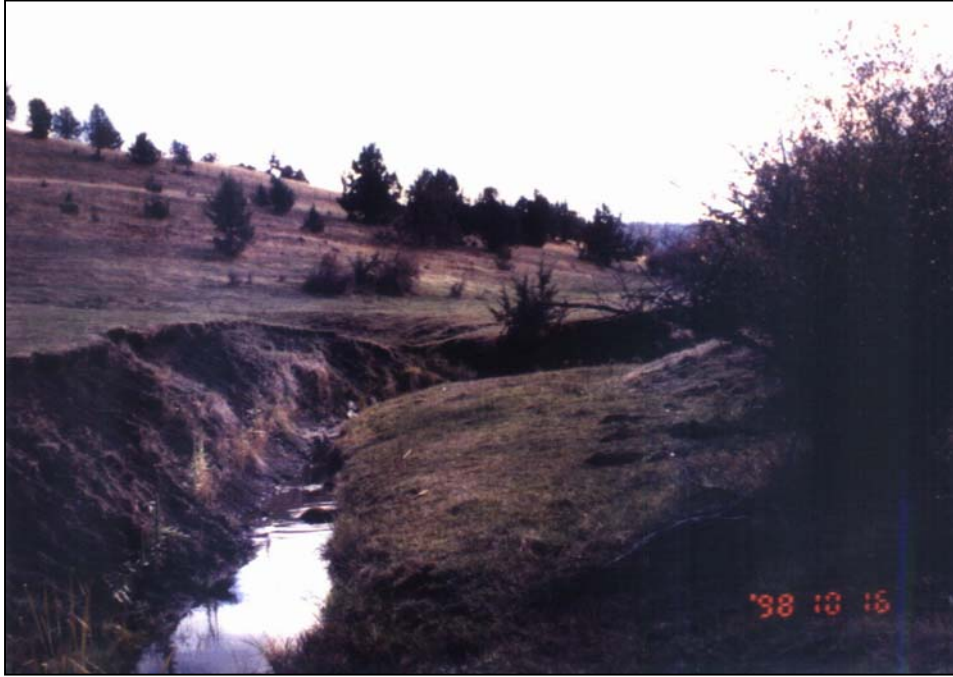
Photo 20 . Basin Creek on the J-Dot Ranch. Beaver reintroduction site prior to release.

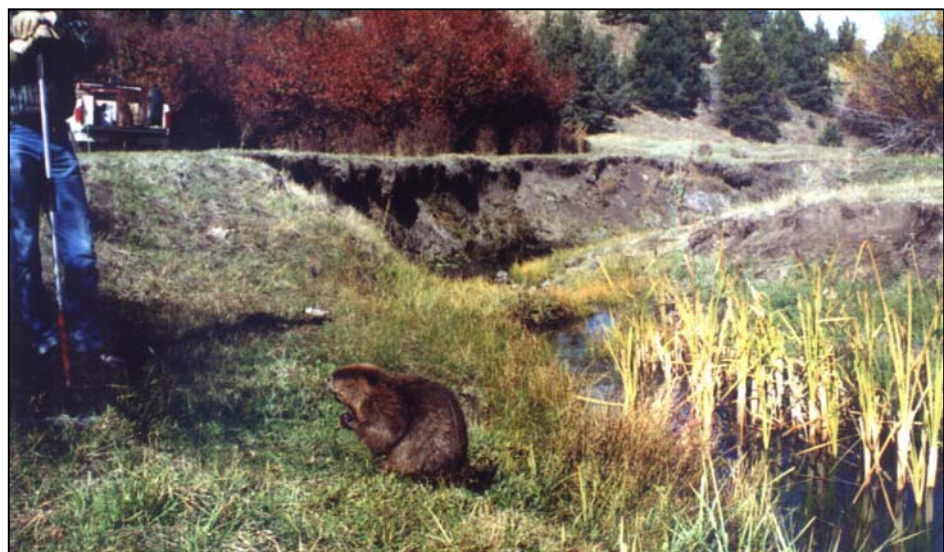
Photo 21. Beaver being released on Basin Creek

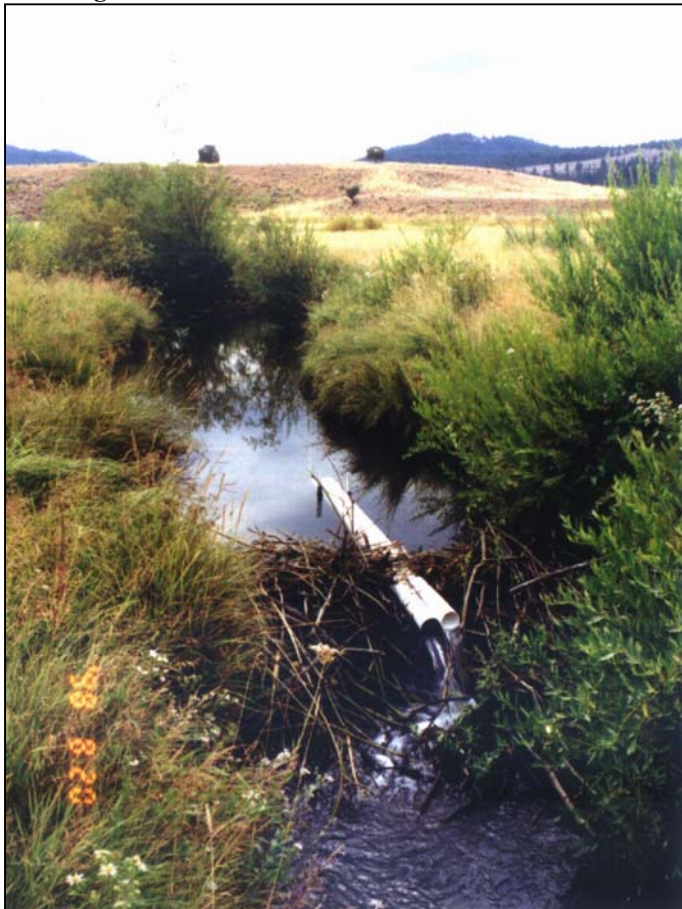
Photo 23 . Basin Creek on the J-Dot Ranch. Beaver reintroduction site showing impounding of water and enhanced willow growth following release.

One of the most successful reintroductions has been on Basin Creek, a tributary to Long Creek, within the J-Dot Ranch. Historically, Basin Creek had an extensive riparian community with beaver dams located along its entire length. Based on interviews with the landowner, these beaver ponds contained significant numbers of fish, probably juvenile steelhead and resident redband trout. These ponds were a favorite local fishing spot and, according to the landowner, “gunny sacks full of fish” could be caught from these ponds in a single day. However, the ponds and beaver dams created considerable problems for the landowner by flooding hay meadows and creating marshes where livestock could become trapped and drowned. In response, the landowner had all of the beavers trapped and the dams blown up with dynamite (this was over thirty years ago).

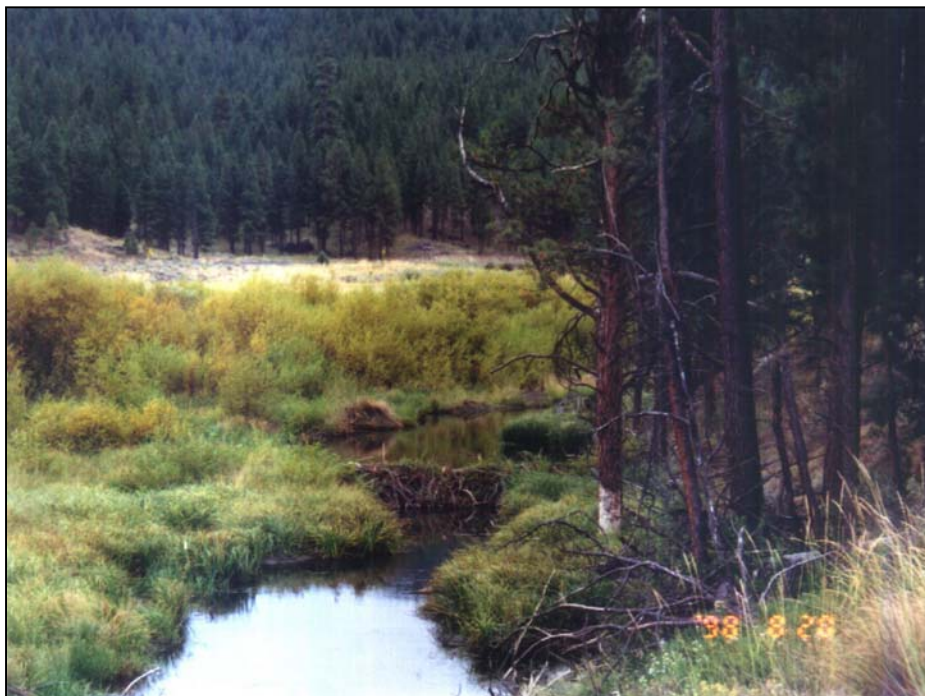
Photo 24 . Beaver pond on the T.G. Brown Ranch, South Fork of the John

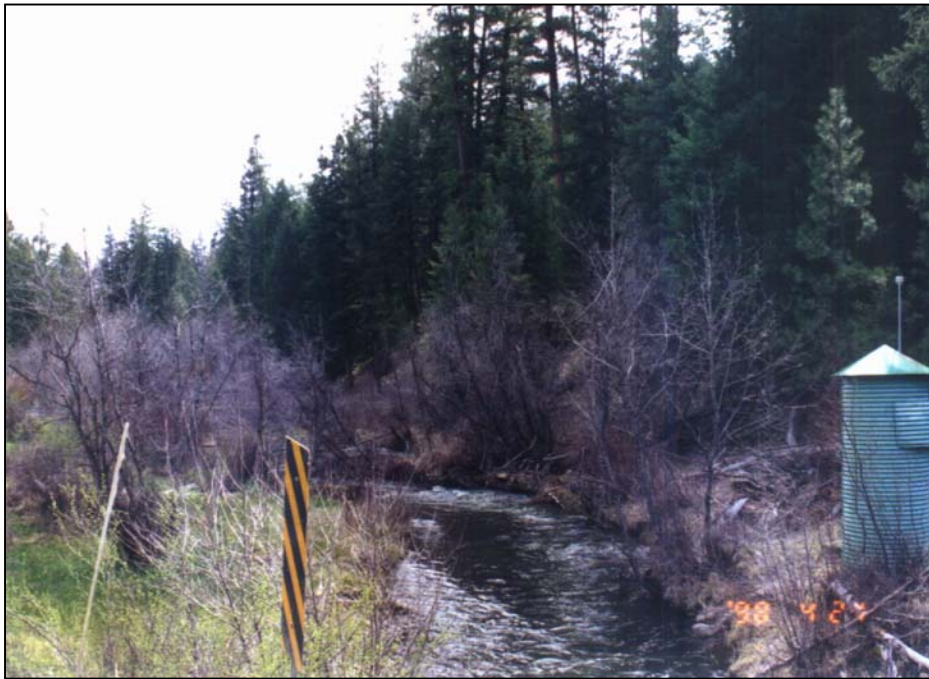
Photo 25. A stream gauging station in the John Day basin.

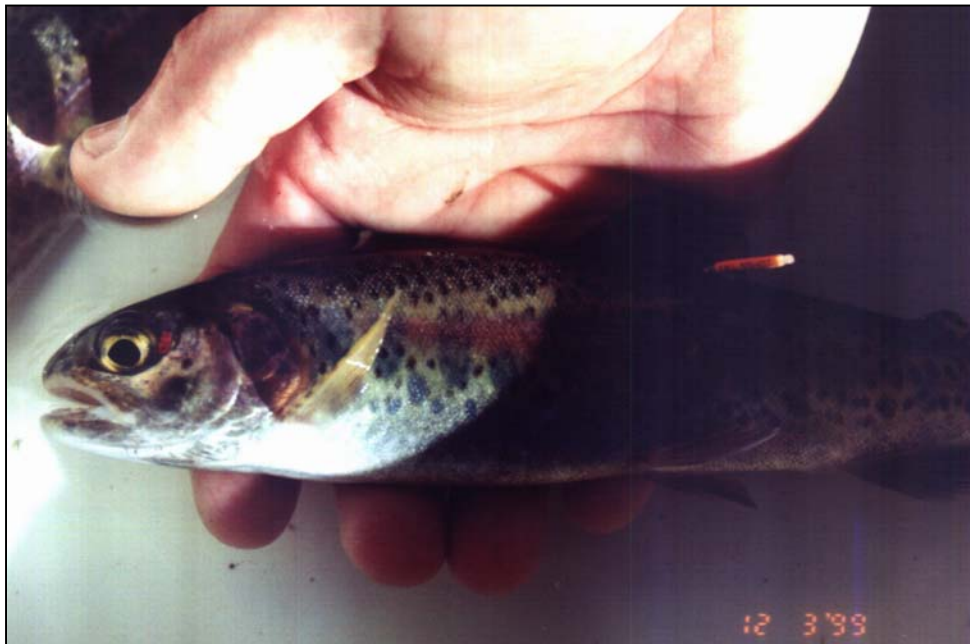
Photo 28. A redband trout (*O. mykiss*) tagged with both a Floy® Anchor Tag (under dorsal fin) and a VI Alphanumeric tag (in perocular tissue behind eye)

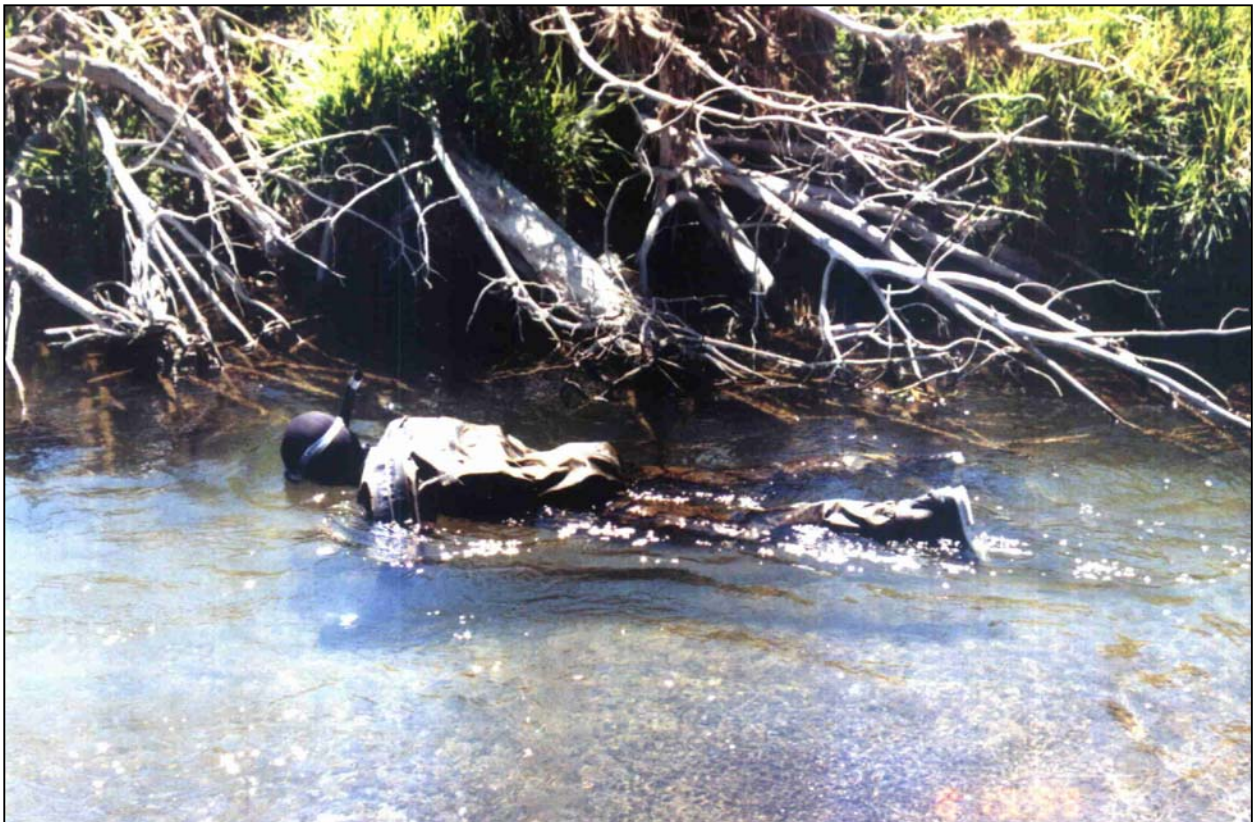
Photo 29. Conducting snorkel surveys on the South Fork John Day River (St. Clair Ranch)

1. Permanent photopoints were installed and pre- and post-project photographs were taken at the proposed project locations.
2. Monitoring stations to assess changes in channel morphology were installed at the St. Clair Seasonal Riparian Corridor (4), St. Clair Permanent Riparian Corridor (4), Crown Ranch Diversion, Morris/Pike Diversion, Rudishauser Infiltration Gallery, Lemon Diversion, and Holmes Diversion projects.
3. Monitoring Stations to evaluate changes in riparian condition were installed at the St. Clair Seasonal Riparian Corridor (4), St. Clair Permanent Riparian Corridor (4), and Oxbow Ranch (5) projects.
4. Snorkel surveys to assess gross abundance and community composition were conducted at the Oxbow
